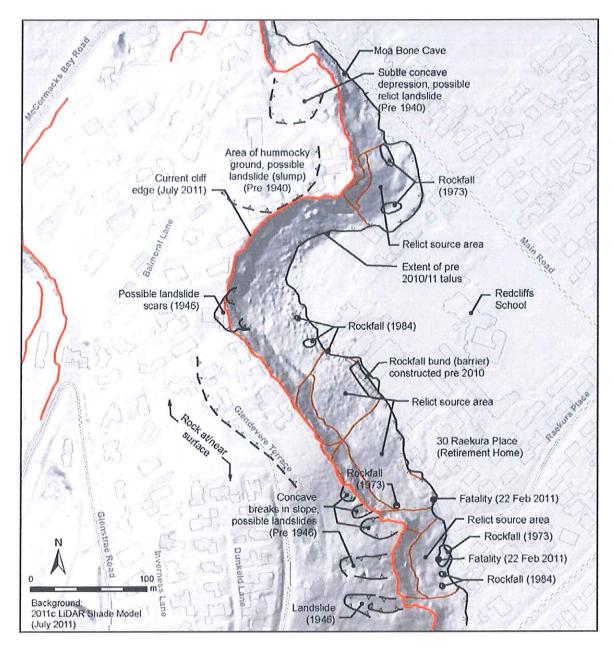
Figure 10 Main features identified at the site from field mapping and the interpretation of historical aerial photographs.

A possible recent collapse of the cliff edge is apparent in the north east corner of the site (Figure 10).
		Several relict and recent loess failures, at the cliff crest, are apparent.
		No dwellings are present at the cliff crest. The area behind the cliff crest still appears to be farmland.
		A few possible recent boulders are apparent on the surface at the cliff toe.
1973, 1:10,000 (approx.)	Poor resolution	A few dwellings have now been constructed at the cliff crest in the central part of the site.
	ľ	Several possible recent rockfalls are present at the bottom of the cliff (Figure 10).
		Several brighter areas are apparent on the cliff face, these may relate to recent failure of material from the cliff.
1975, 1:10,000 (approx.)	Poor resolution	No obvious change. Much of the cliff face and toe is in shadow. A few more buildings have been constructed at the cliff crest.
1984, 1:6,000 (approx.)	Good resolution	A few more dwellings have now been constructed at the cliff crest in the central and northern part of the site. Several possible recent rockfalls are present at the bottom of the cliff

- There are several possible rockfalls visible in historical aerial photographs (Figure 10).
- A rockfall bund (a barrier constructed of rock fill to prevent rockfalls from passing it)
 was constructed in 2010 behind the Redcliff School hall (Figure 10).
