1 Introduction

MWH New Zealand Limited (MWH) is providing geotechnical advice to the Ministry of Education (MoE) regarding the geotechnical hazard presented by the cliffs immediately behind Redcliffs School, located in Sumner, Christchurch.

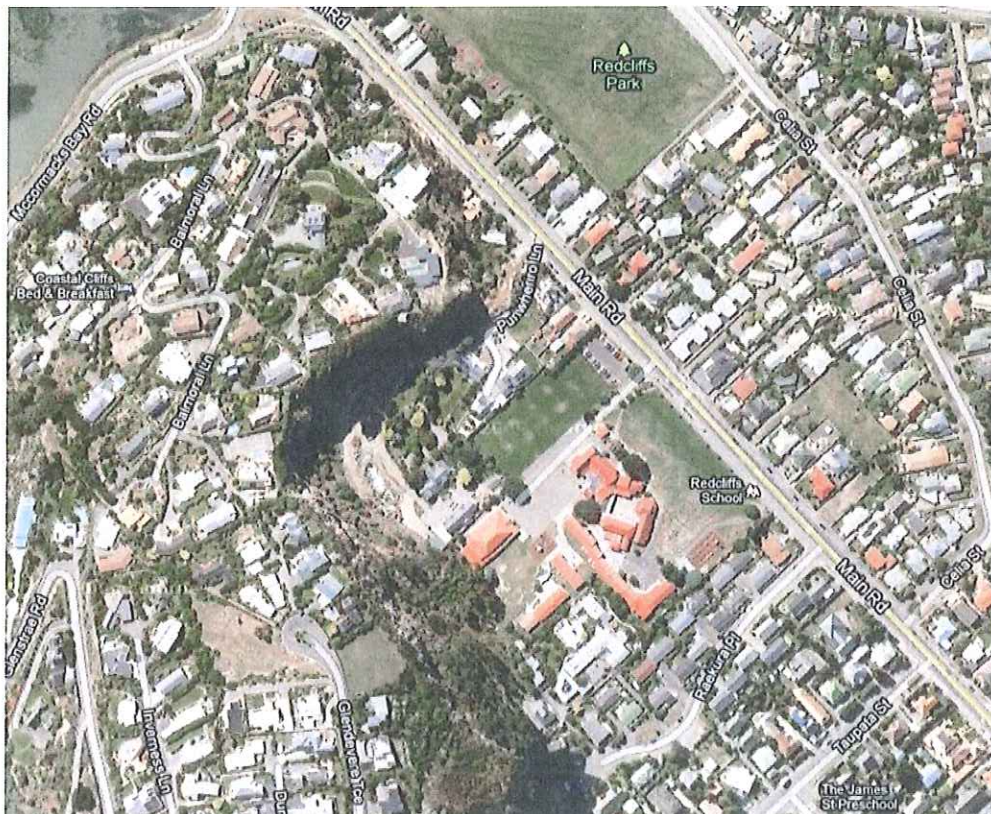
Photo 3-1 – Aerial Photo of Redcliffs School Pre-September 2010 (from Google Maps).

The predominant mechanism of failure in the cliffs behind the school site is block failure. Photo 3-1 shows the cliffs prior to the seismic event of 4th September. Following the September 2010 event, the dominant failure mechanism appears to have been block failure with boulders observed at the base of the cliff and in the talus slope (apparent in Photo 3-2).

An aerial photograph showing the cliffs behind Redcliffs School prior to the seismic events is shown in Photo 3-1. To our knowledge, there is no aerial survey (LIDAR) data available for the period prior to February 2011 and therefore it is difficult to define historical talus slopes. However, the photograph shows a talus slope is present behind the school hall. The estimated pre September 2010 slope of the cliffs behind the school based on Google Earth Pro is approximately 65° to 70° with the talus slope being approximately 35 to 40°. Figure 3-1 shows a generalised cross section of the cliffs behind the hall.

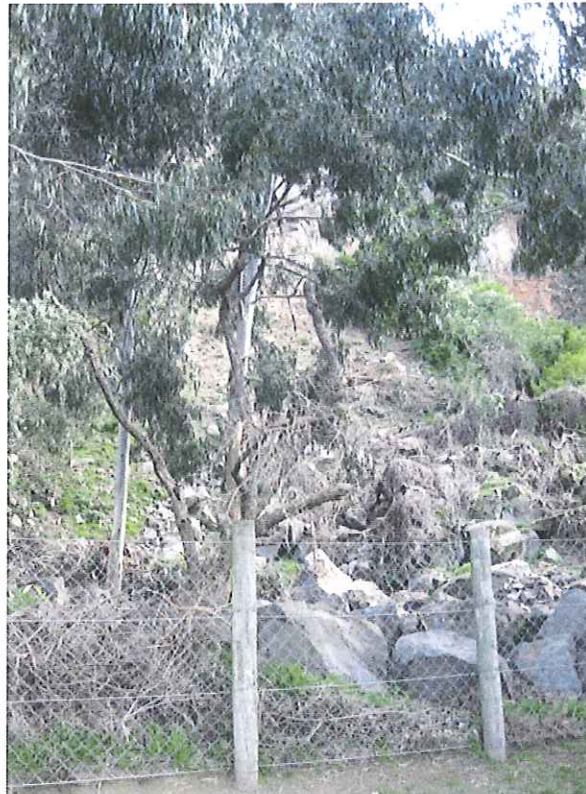
Photo 3-2 – Boulders at the Base of Catch Fence post the September Earthquake.

Prior to the earthquake occurring on 4th September 2010 and subsequent aftershocks, there was evidence for cliff instability behind Redcliffs School. Large boulders (estimated to be up to 1 m³) were present at the base of the cliff where a scree slope had developed. Rockfalls are prone to occur on steep cliffs as the bulk rock mass properties may have been weakened by weathering or quarrying activities.
