**ENGINEERING GEOLOGY MODEL**

**Redcliffs Christchurch**

REPORT: CR2014/78 DATE: August 2014

**GNS SCIENCE**

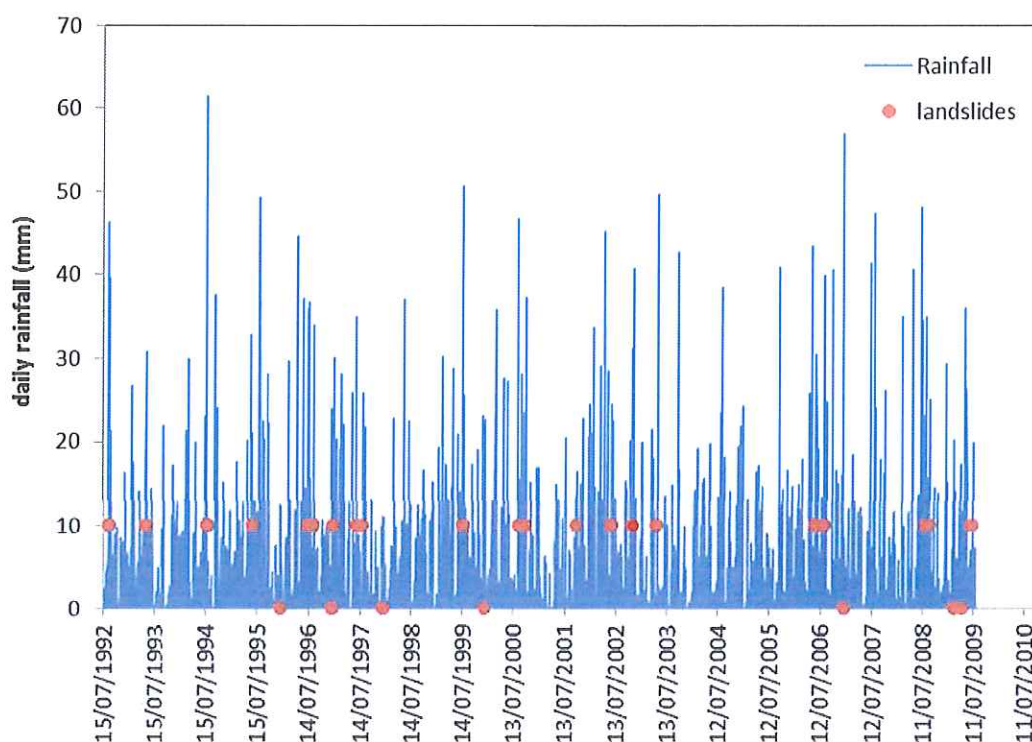
**Figure 16** Daily rainfalls at Christchurch Gardens and landslides in the Port Hills. Daily rainfalls at Christchurch Gardens and landslides in the Port Hills investigated by Geotechnical Consulting Ltd, or listed by the Earthquake Commission as causing damage to homes. Landslides without rain are plotted at 0 mm, all others are plotted at 10 mm of rain (the minimum rainfall for triggered landslides).

McSaveney et al. (2014) conclude that the comparison of the record of damaging landslides (including rockfalls) and daily rainfall for the period 1992–2010 shows that:

1. Landslides can occur without rain, but the probability of landslides occurring increases with increasing intensity of rainfall;
2. Landslides occurred much more frequently on days with rain, but there were many rainy days when no landslides were recorded; and
3. As the amount of daily rainfall increased, a higher proportion of the rainy days had recorded landslides.

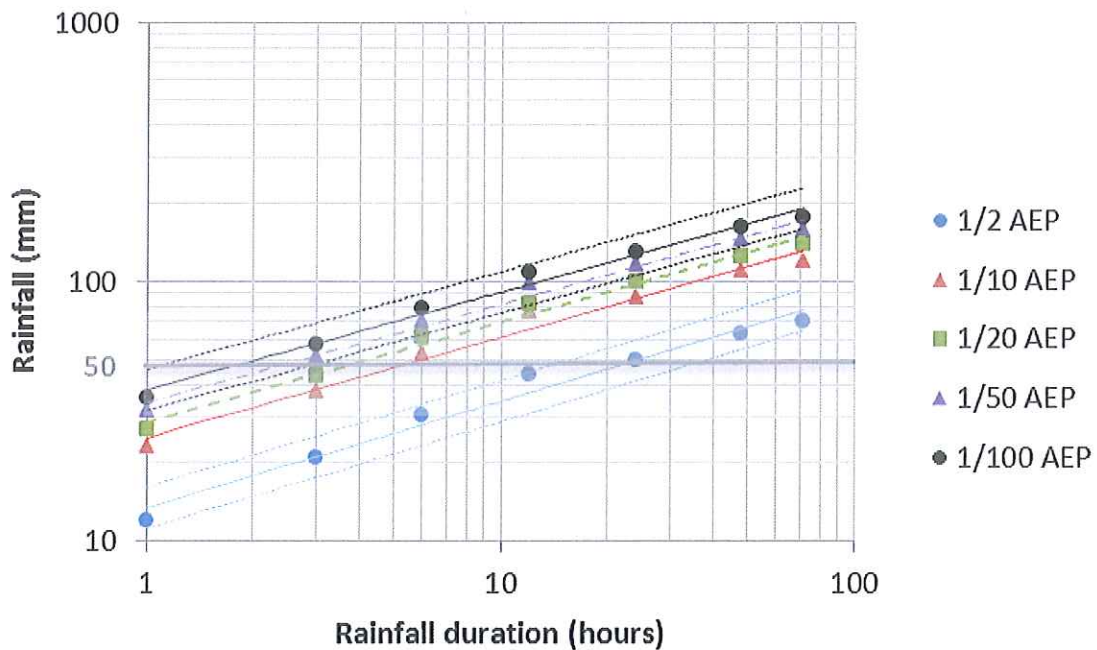
**Figure 17** Rainfall depth-duration-return period relations estimated for Christchurch Gardens by Griffiths et al. (2009) using recorded rainfall data. Error limits of 20% are shown by dotted lines for the 1/2 and 1/100 AEP curves. Shaded area covers the range of 30–75 mm of rainfall over which the expected number of soil landslides in the Port Hills rises from very few to many. Rockfalls can occur without rain, but the probability of rockfalls occurring increases with increasing intensity of rainfall.

Regardless of the rainfall data sets used, the rainfall data suggest that the heavy rainfalls recorded in the Port Hills following the 2010/11 Canterbury earthquakes are unexceptional. Although the three-day rainfall of 118 mm had an annual frequency of 0.05–0.1 (once every 10 years), it occurred at the end of summer when the ground would have had a seasonally low water content.

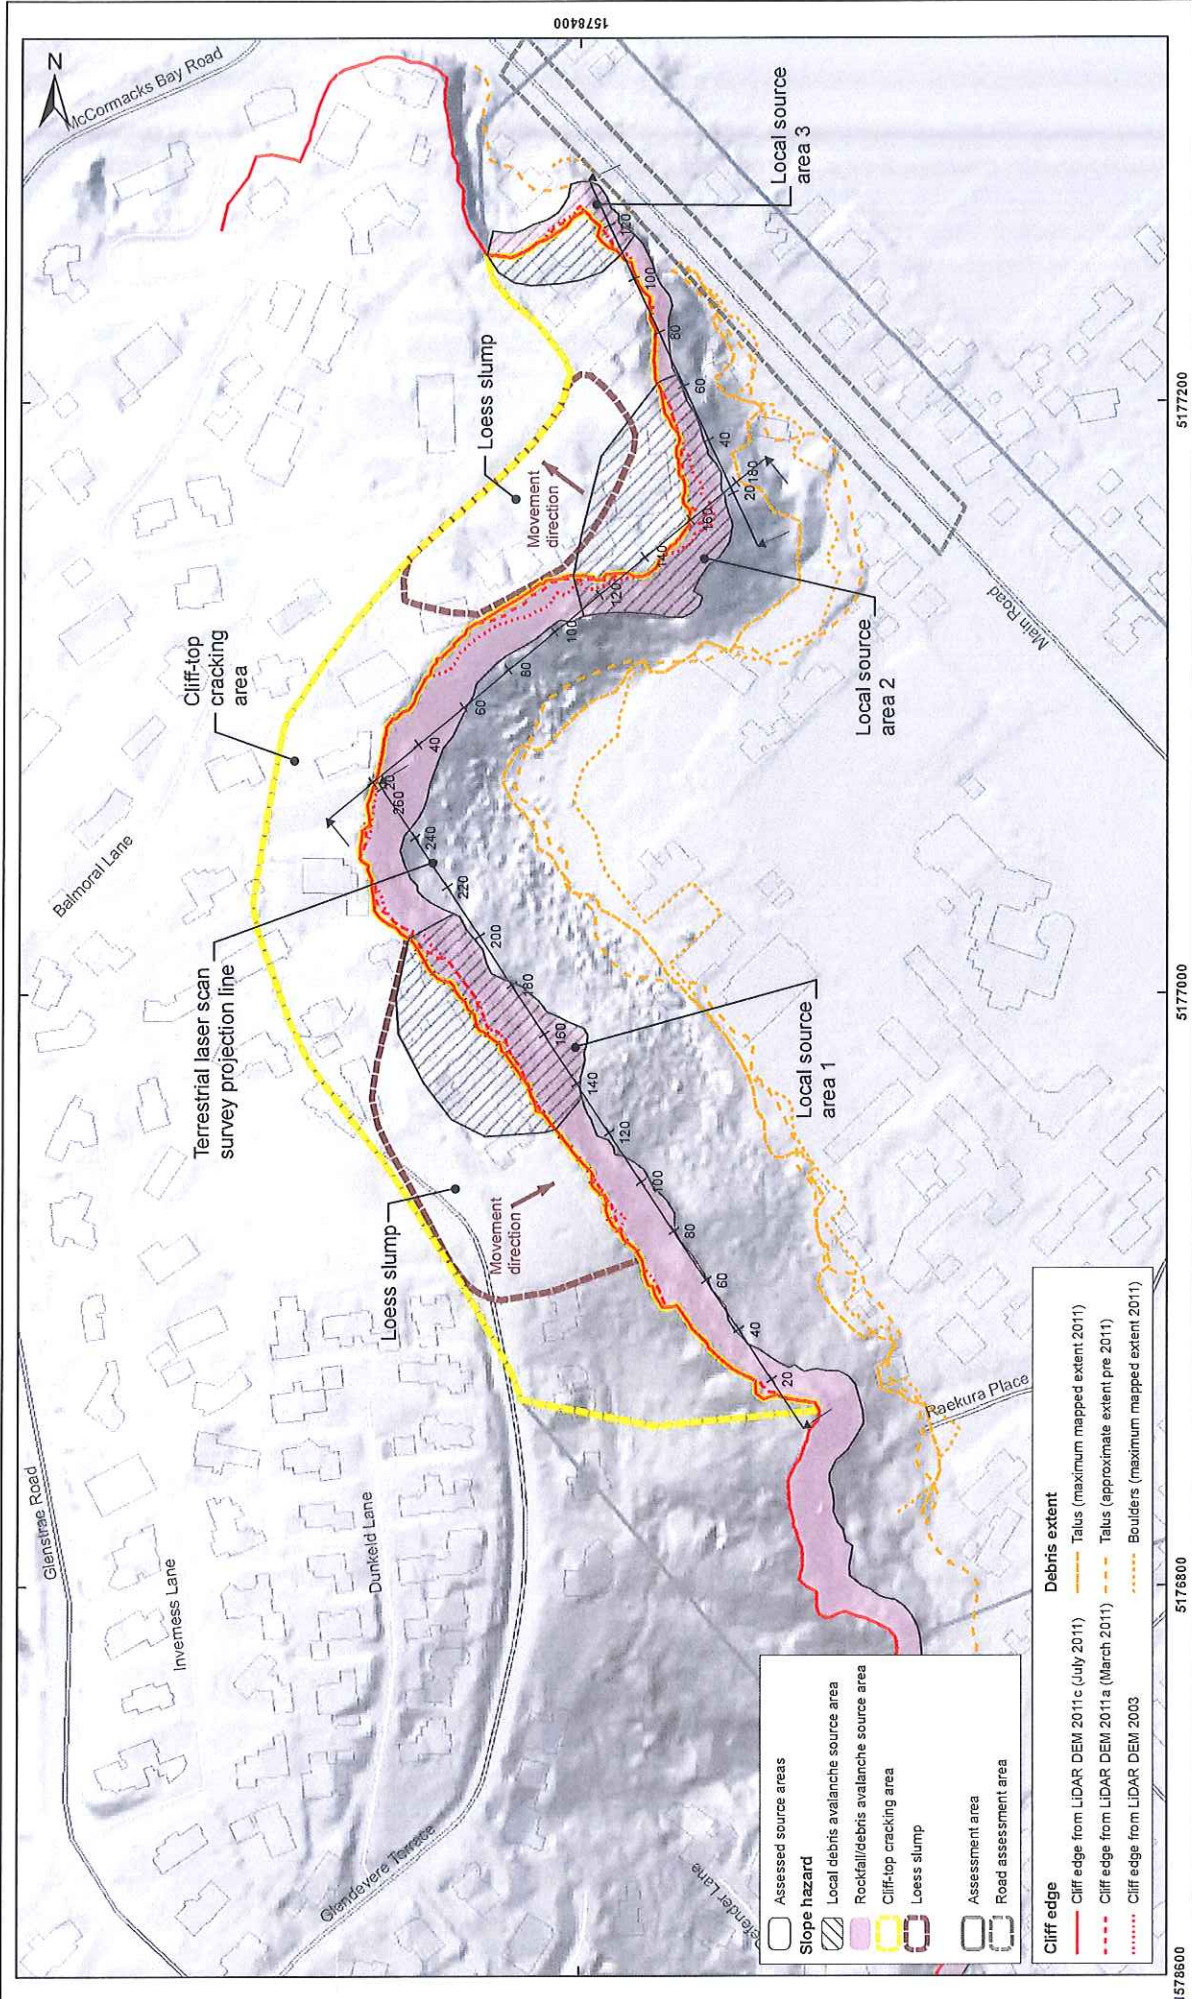
**FIGURE 18**

Based on the past performance of the cliffs in the study area, cliff-collapse hazards (cliff-top recession and debris avalanches) pose the greatest landslide hazard and therefore landslide risk to people at the cliff crest and cliff toe. These slope-instability processes form the basis of the following hazard and risk assessments, and their potential source areas are shown on Figure 18.
