1.3 PREVIOUS WORK AT THE REDCLIFFS SITE

1.4 SCOPE OF THIS REPORT

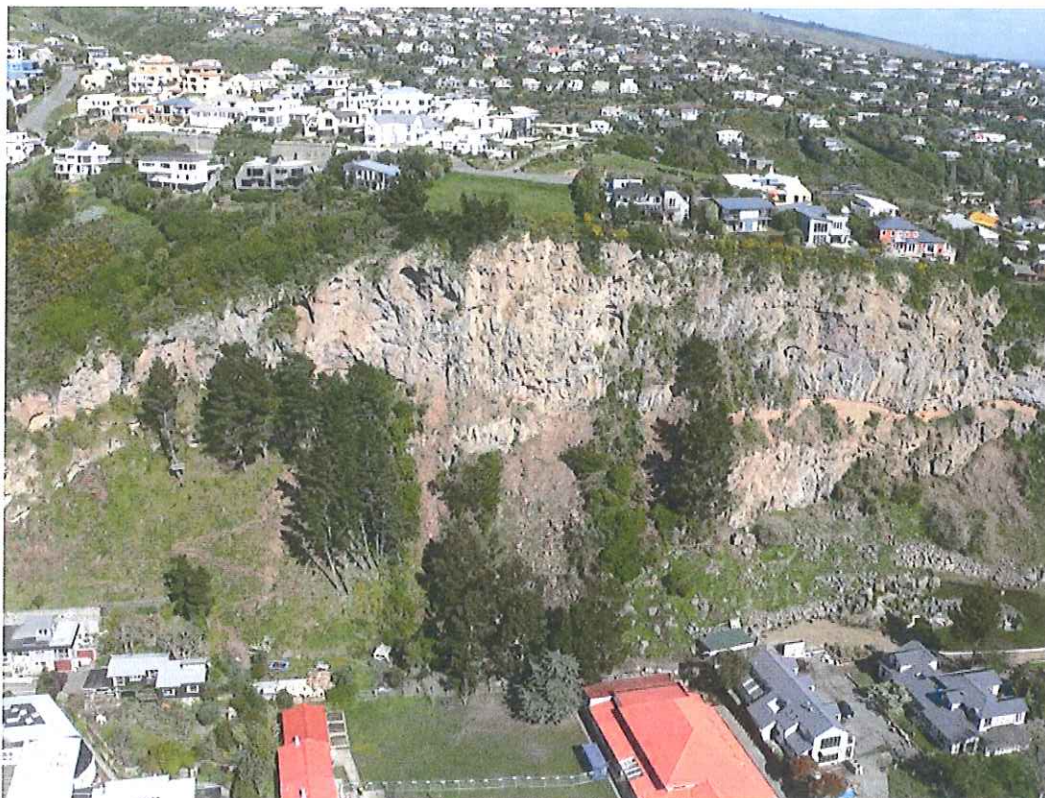
Figure 3 Aerial view of the Redcliffs mass movement area after the 4 September 2010 (Darfield) earthquake and before the 22 February 2011 earthquakes. Photograph taken by M. Yetton.

During the 22 February 2011 earthquakes, within the Redcliffs mass movement area, significant volumes of debris fell from the steep rock slope (debris avalanches), inundating dwellings at the cliff bottom, along with localised recession and cracking of the cliff crest. These have been collectively termed cliff-collapse hazards (Figure 3–Figure 9). Previous investigations of the site comprised:

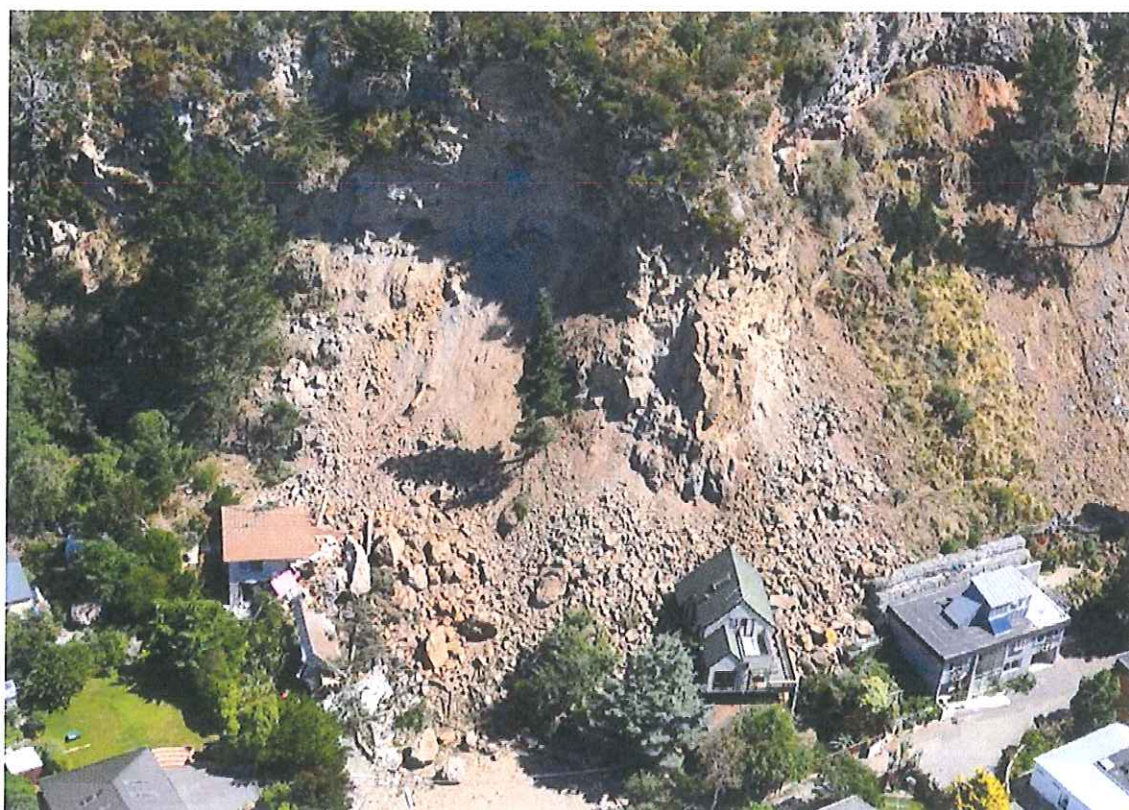
Figure 6 Aerial view of the Redcliffs mass movement area after the 22 February 2011 earthquakes and before the 13 June 2011 earthquakes. Photograph taken by G. Hancox.

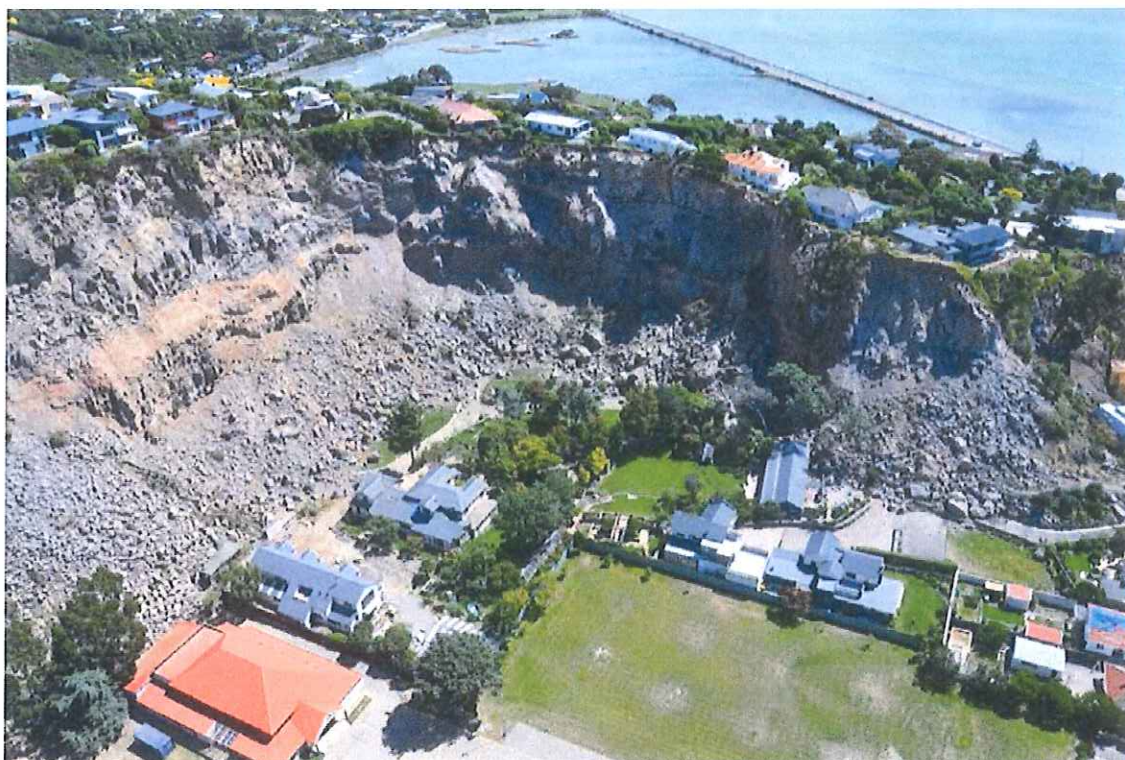
Figure 7 Aerial view of the Redcliffs mass movement area after the 22 February 2011 earthquakes and before the 13 June 2011 earthquakes. Photograph taken by G. Hancox.

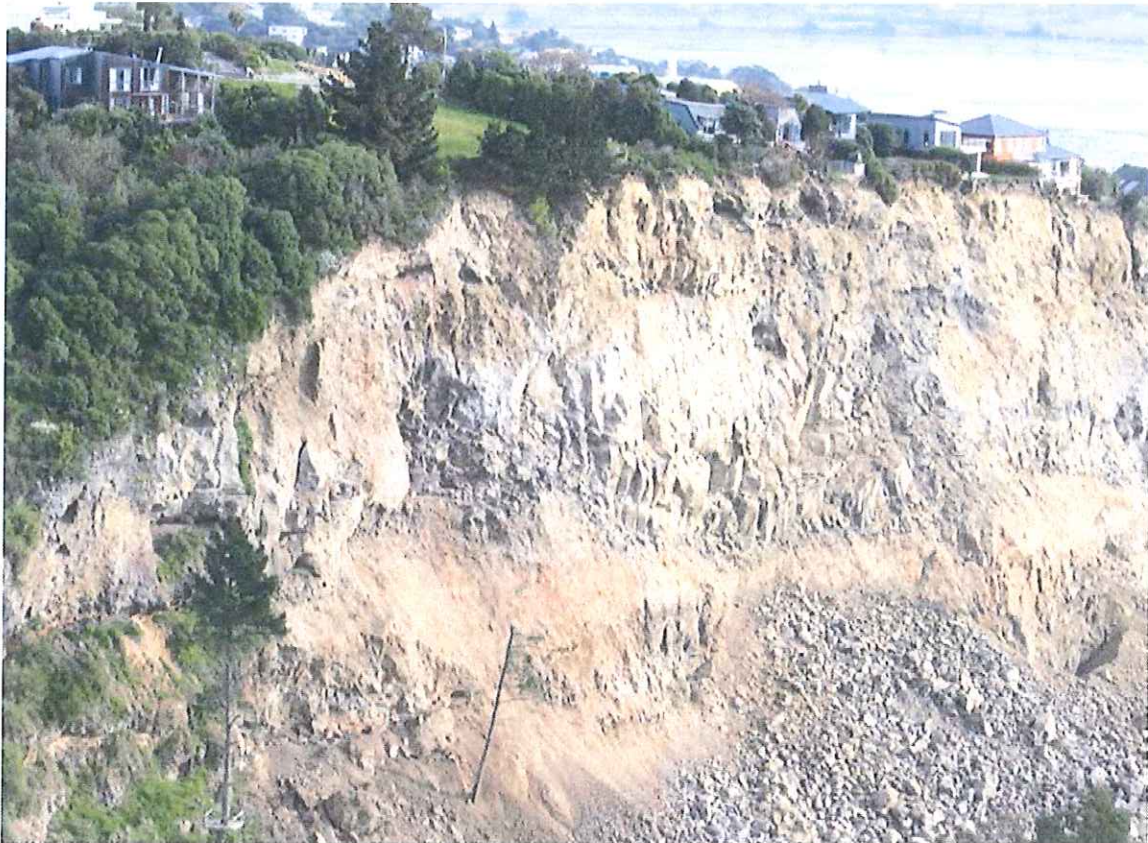
Figure 9 Aerial view of the Redcliffs rock slope after the 13 June 2011 earthquakes. Photograph taken by C. Massey.
