4 Rockfall Modelling

4.2 GNS Modelling

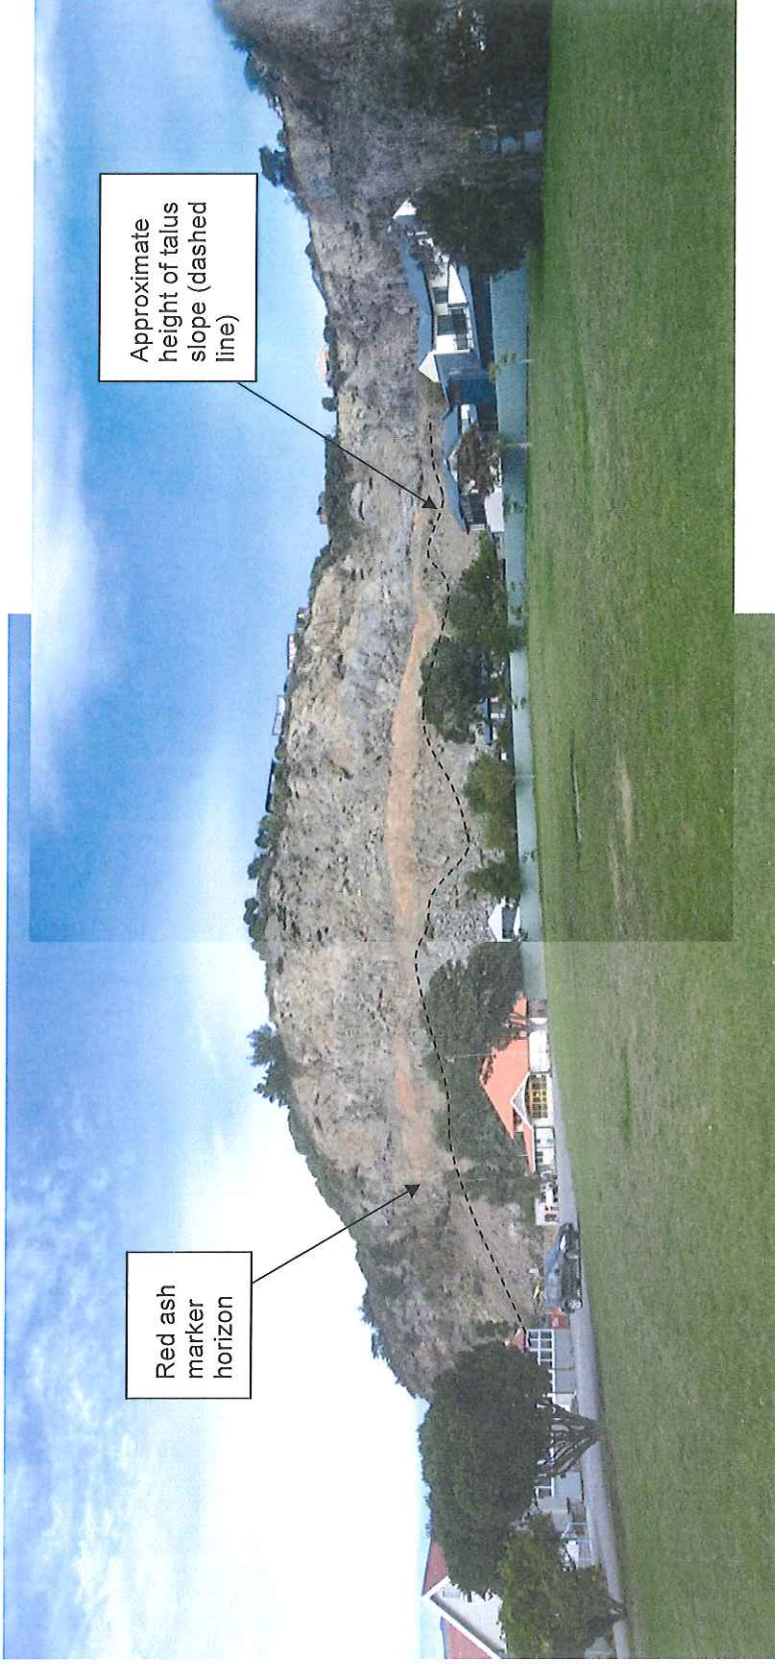
Photo 3-3 – Cliffs above Redcliffs School following February 2011 Earthquake.

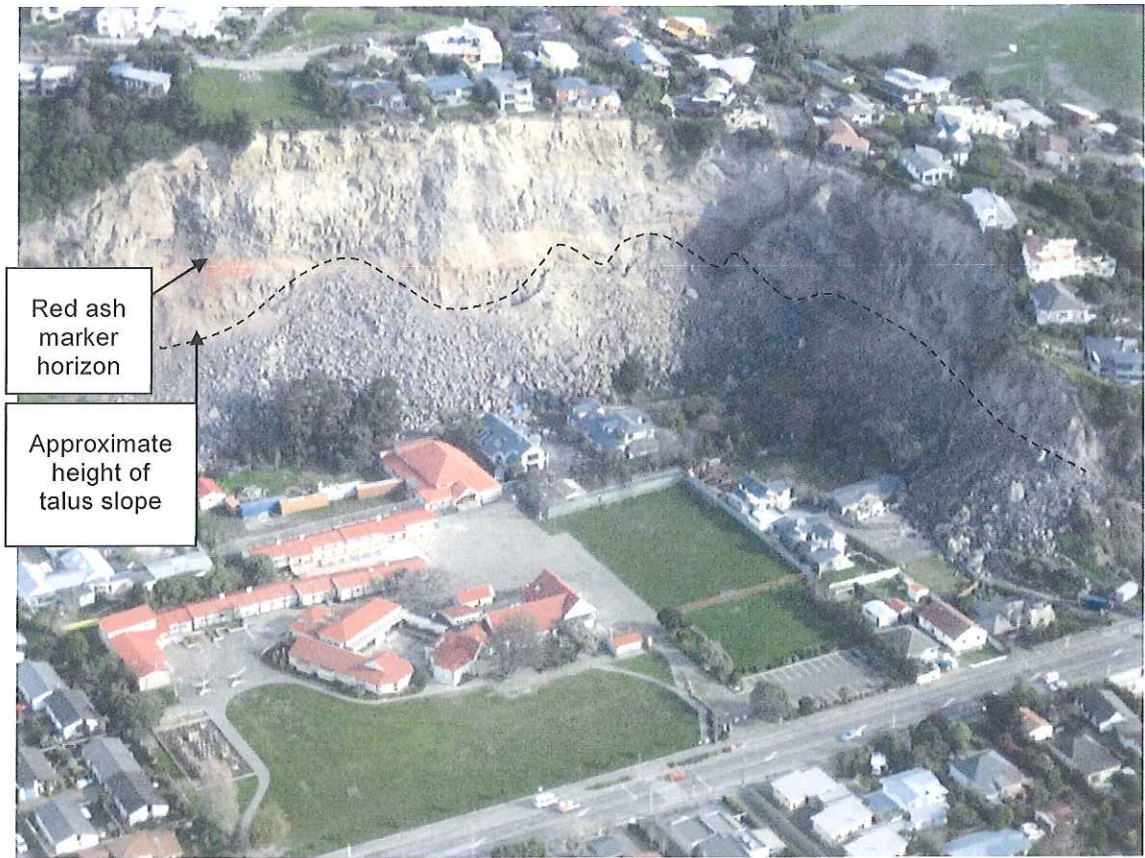
Photo 3-4 – Cliffs above Redcliffs School following June 2011 Earthquake.

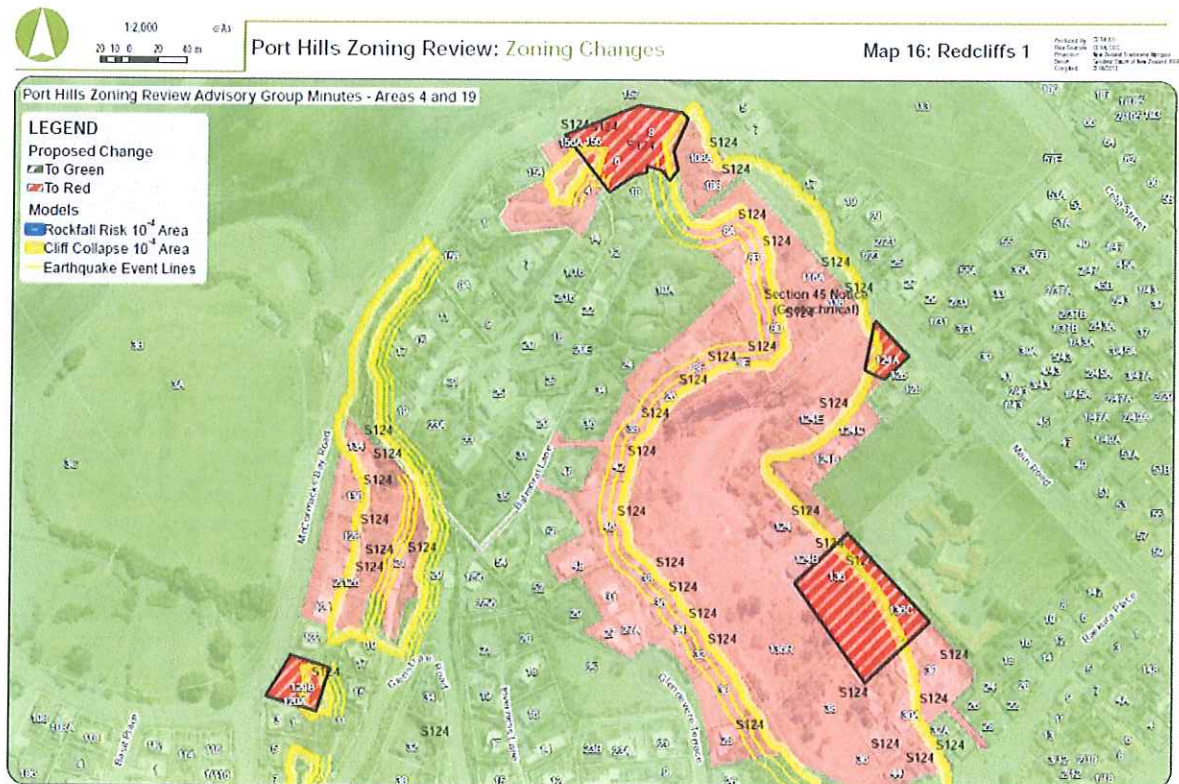
The GNS risk modelling has been used as the basis of zoning decisions of residential properties around the Port Hills. Red zoned properties (shown in red on the following figure) are those where the risk is considered too high for ongoing occupation.

Figure 4-4 shows the zoning of properties immediately adjacent to the school. It can be seen that the properties on the western and southern (cliff facing) boundaries have been red zoned, except for the two properties on Main Road which will remain occupied. The parcel of land that is part of the school grounds and closest to the southern cliffs (shown in red stripes on Figure 4-4) has also been red zoned.

Figure 4-4 – Residential Zoning around Redcliffs School.
