4.3 Current Modelling

4.3.1 Model Overview

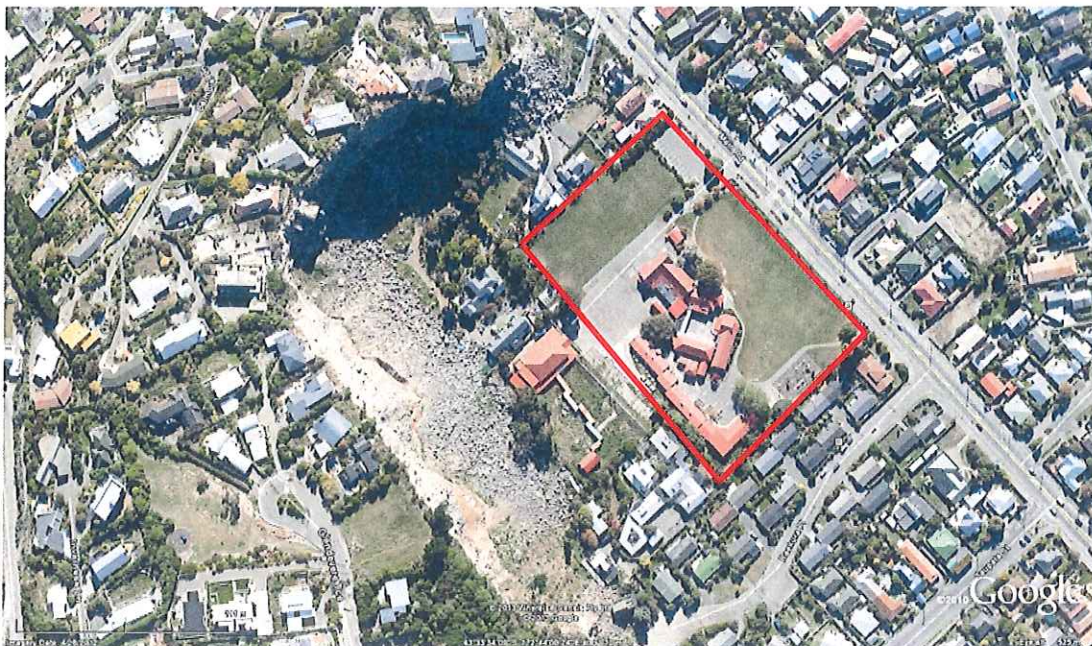
Figure 4-5 – Revised School Boundaries adopted in Modelling.

Based on the risk assessment presented in figure 4-1 to 4-3 and the red zones illustrated in figure 4-4 it has been determined in consultation with the MoE that the most at risk portion of the school site will be abandoned. The model considered by MWH focusses on what rock may reach the revised school boundary, which is shown highlighted by the red lines in the figure below.

- Case 1 - Rockfalls from the current slope (as measured by LIDAR survey flown after the major rockfalls in February 2011)
- Case 2- An intermediate case where there has been a partial regression of the slope as shown in the shaded areas of figure 4-6 above, extending the talus slope closer to the existing container protection works.
- Case 3 - A volumetric assessment at three cross sections to determine whether, in the case of full regression of the slope a sufficient volume of rock could fall to inundate the area behind the revised school boundaries shown in figure 4-5.

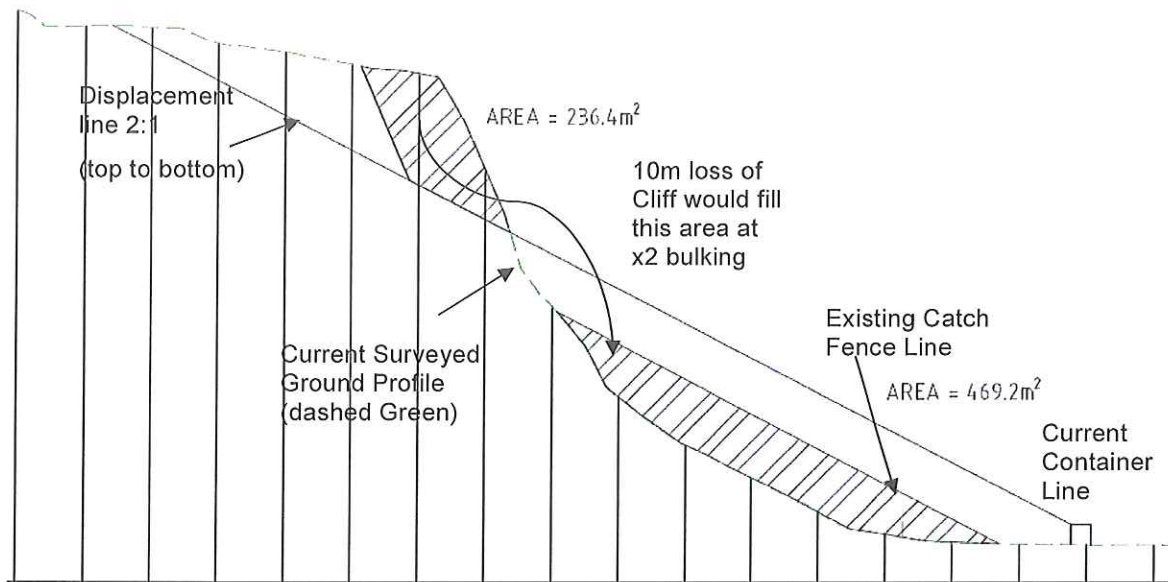
Figure 4-6: Modelled Potential Cross Section with Notes

Figure 4-6 shows the conceptual model development which is based on the cross section to the south of the existing school hall (Figure 1 in MWH March 2011 report). The hypothetical stages of cliff failure taken into account in the model are:

- The slope profile following the February 2011 earthquake is shown by the green line and resulted from material from the upper cliff face falling and enlarging the existing talus slope at the base of the cliffs. Minor changes to this profile occurred following the June 2011 event; however, comparison of LIDAR between the two events indicated little change in the modeled cross section. Relative to the extreme design case being considered, the changes to the slope between February and June are not considered significant to the subsequent analysis.

- A future potential large scale failure at the top of the cliffs similar in scale to observed failures on other cliffs in the Sumner/Redcliffs area (refer to the hatched area on figure 4-4 below). A conservative estimate is that failed material may tip to form a loose deposit with 50% voids, therefore bulking to fill approximately twice the volume at the base of the cliff than that displaced at the top.

- Progressive failure of the slope, either over a series of events or most conservatively one event until the slope regresses to a residual angle. Figure 4-4 presumes a 27 degree (approximately 2H:1V) angle and establishes the geometry of the slope assuming that the fallen material bulking to twice its original volume (i.e. the volume that has fallen from top of the slope is half of the volume that accumulates at the base of the slope). The 2H:1V slope selected is similar to the shallowest slope present within the boulder field on the lower slopes.

It is noted that this model is highly idealised and that in reality defects in the rock mass will control the failure volumes and deposition at the toe will be more irregular. However, it is still considered useful as a secondary check to the GNS modelling to assist in understanding the overall scale of future large scale rockfall events that may occur.

The model assumed the same conditions of relative roughness, and elasticity for the slope as was modelled in Case 1 but assuming failure of the slope in accordance with the shaded areas in Figure 4-6. In this instance we modelled the largest of the three boulder sizes trailed as previous modelling confirmed that this produced the highest bounces, velocities and travel distances. The modelling is outlined in more detail in Appendix C.

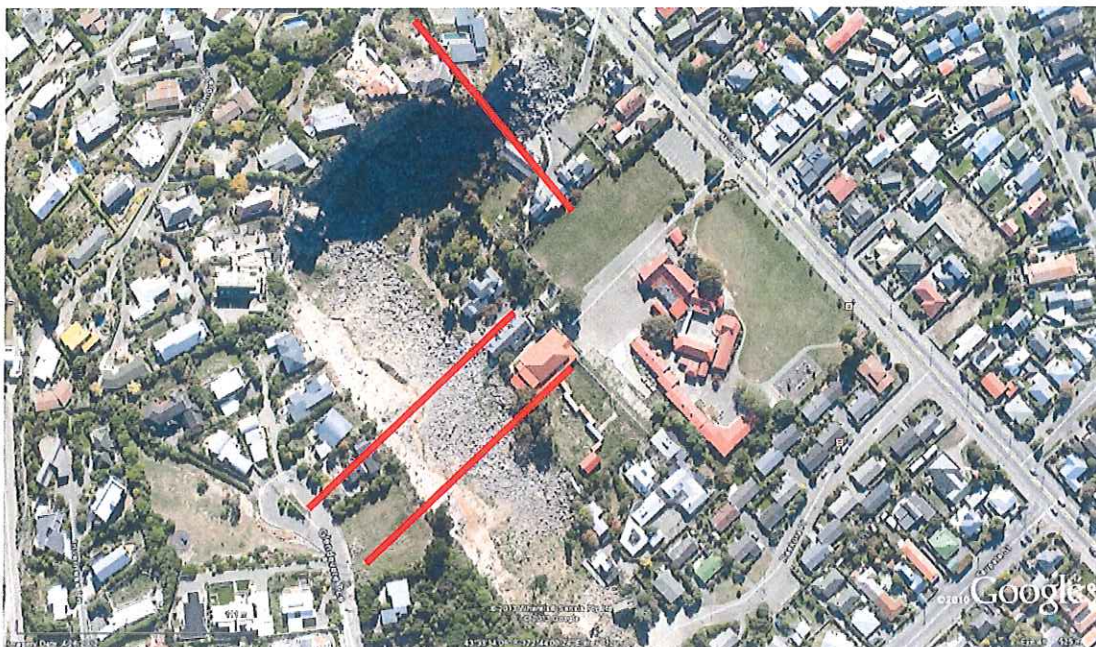
Figure 4-7: Location of Cross Sections.

Three cross sections were considered as part of this case, located as shown in the following figure. The model considers the potential for a large scale regression of the slope to a residual 2H:1V slope. Material falling from the top of the slope is assumed to double in volume at the base of the slope (bulking factor of 2). The assessment is undertaken based on LIDAR data collected after the June 2011 event and is considered a good approximation to the current slope geometry.

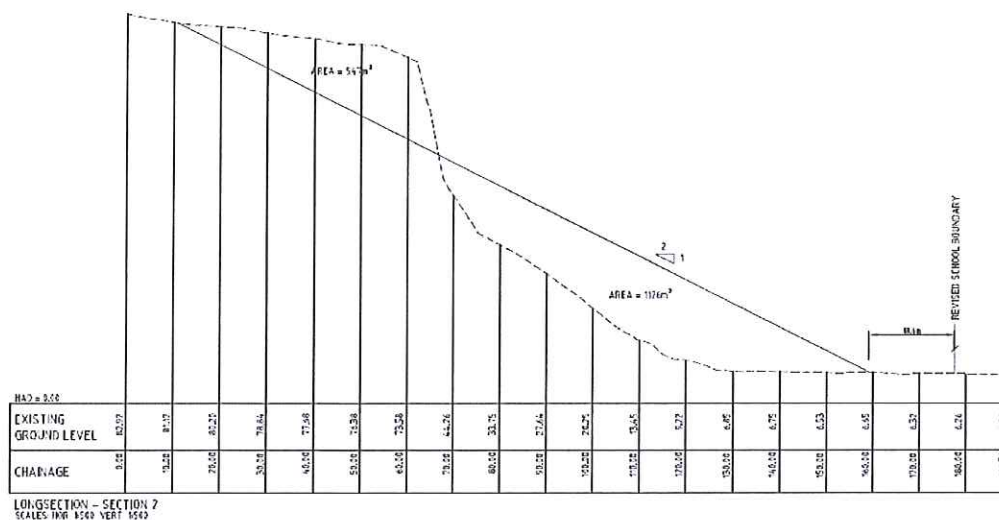
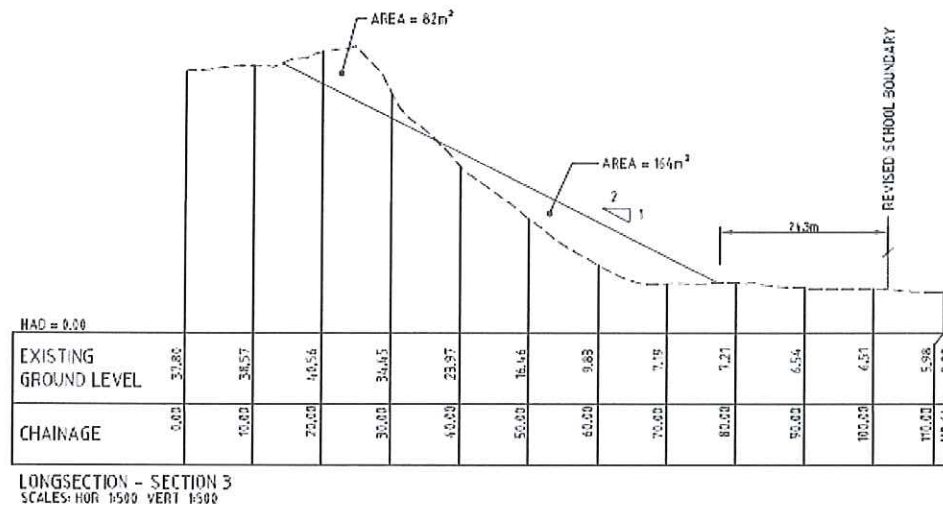
Figure 4-8: Hypothetical and simplified volumetric assessment

It is noted that the GNS RAMMS modelling discussed in section 4.2.2 is considered the definitive assessment of potential large scale future cliff collapse events. As a secondary check the situation shown in figure 4-8 indicates similar trends to the GNS modelling with the talus slope stopping some distance short of the revised school boundary. It is acknowledged that the 2H:1V slope regression angle shown in figure 4-8 may not necessarily represent the largest volume that may fall (the volume being controlled by defects in the rock mass and the buttressing effect of the talus slope). However, it can be seen from the figure that there is the potential for a considerably larger volume than that shown to fall at each cross section before the talus slope would fill the volume available behind the revised school boundary.
