**ENGINEERING GEOLOGY MODEL**

**Redcliffs Christchurch**

REPORT: CR2014/78 DATE: August 2014

**GNS SCIENCE**

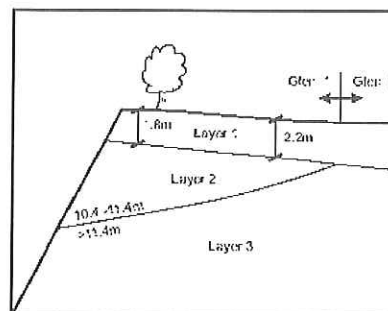
**Table 15** Preliminary layer interpretations of seismic refraction lines Glen\_1 and Glen\_2 (Woelz, 2012).

Seismic refraction line Glen\_1 is closer to the cliff face and within the main zone of mapped surface cracking. It is possible that the recorded P-wave velocities in line Glen\_1, associated with the basalt breccia, reflect increased fracturing of the rock mass near the cliff edge.

Details	Glen_1	Glen_2
Layer 1 depth of base (m below ground level)	1.8–2.1	1.5–2.2
Layer 1 velocity (P-wave) m/s	180–380	510–570
Layer 2 depth of base (m below ground level)	10.4–11.4	-
Layer 2 velocity (P-wave) m/s	590–1,070	-
Layer 3 depth (m below ground level)	>11.4	>2.2
Layer 3 velocity (P-wave) m/s	1,580–1,920	1,580–1,920
