1.0 INTRODUCTION

FIGURE 1	
Map 2	
FINAL	
REPORT: CR2014/78	DATE: August 2014

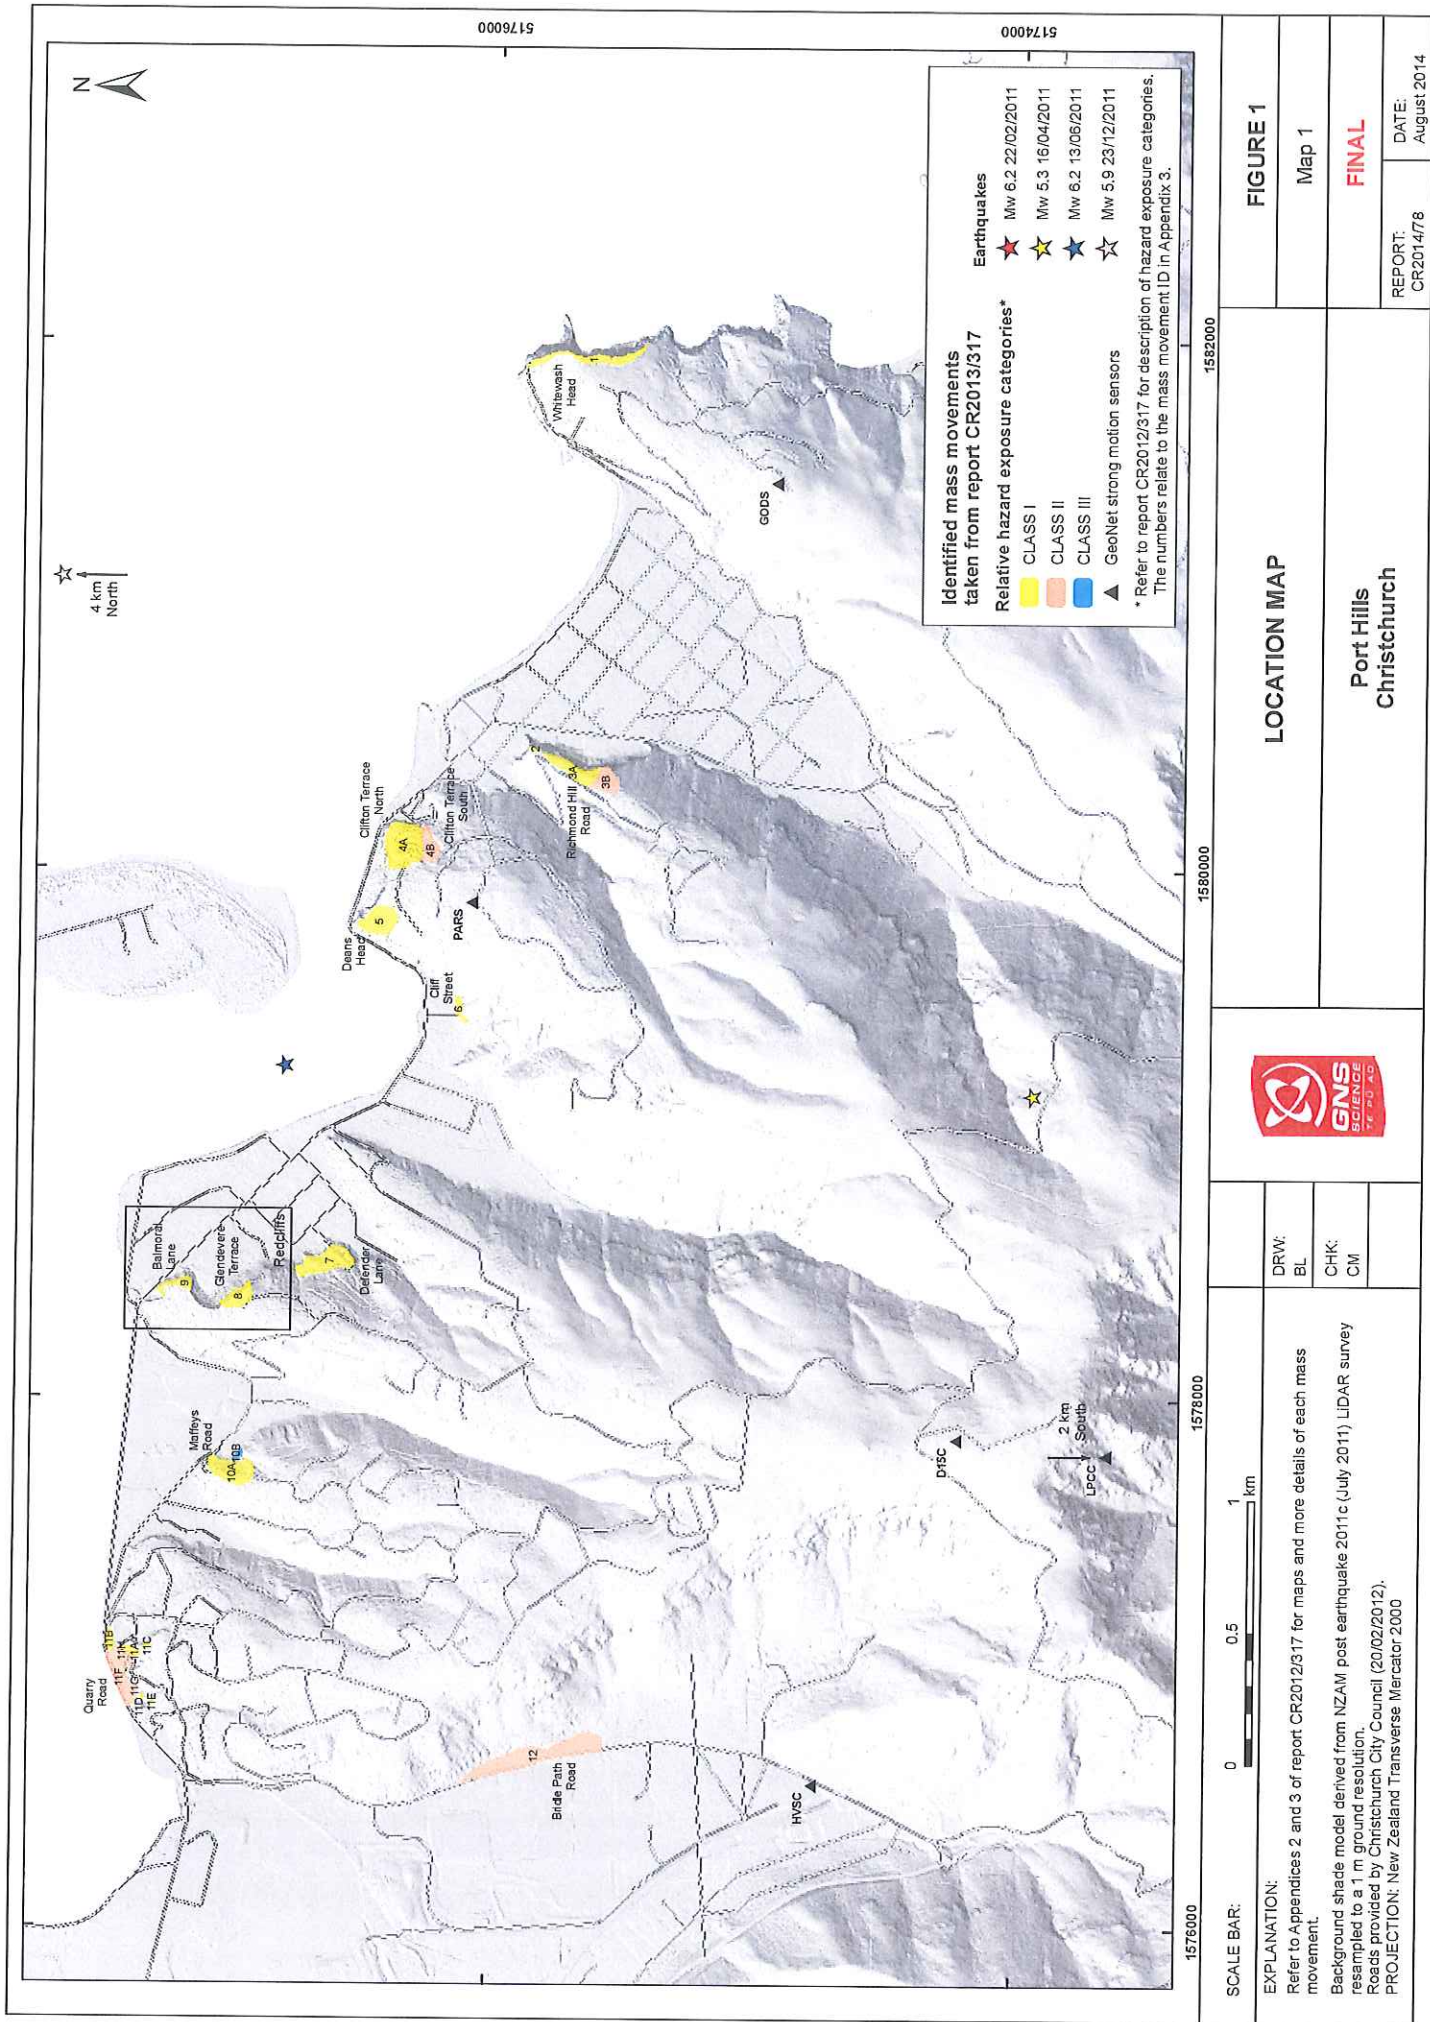
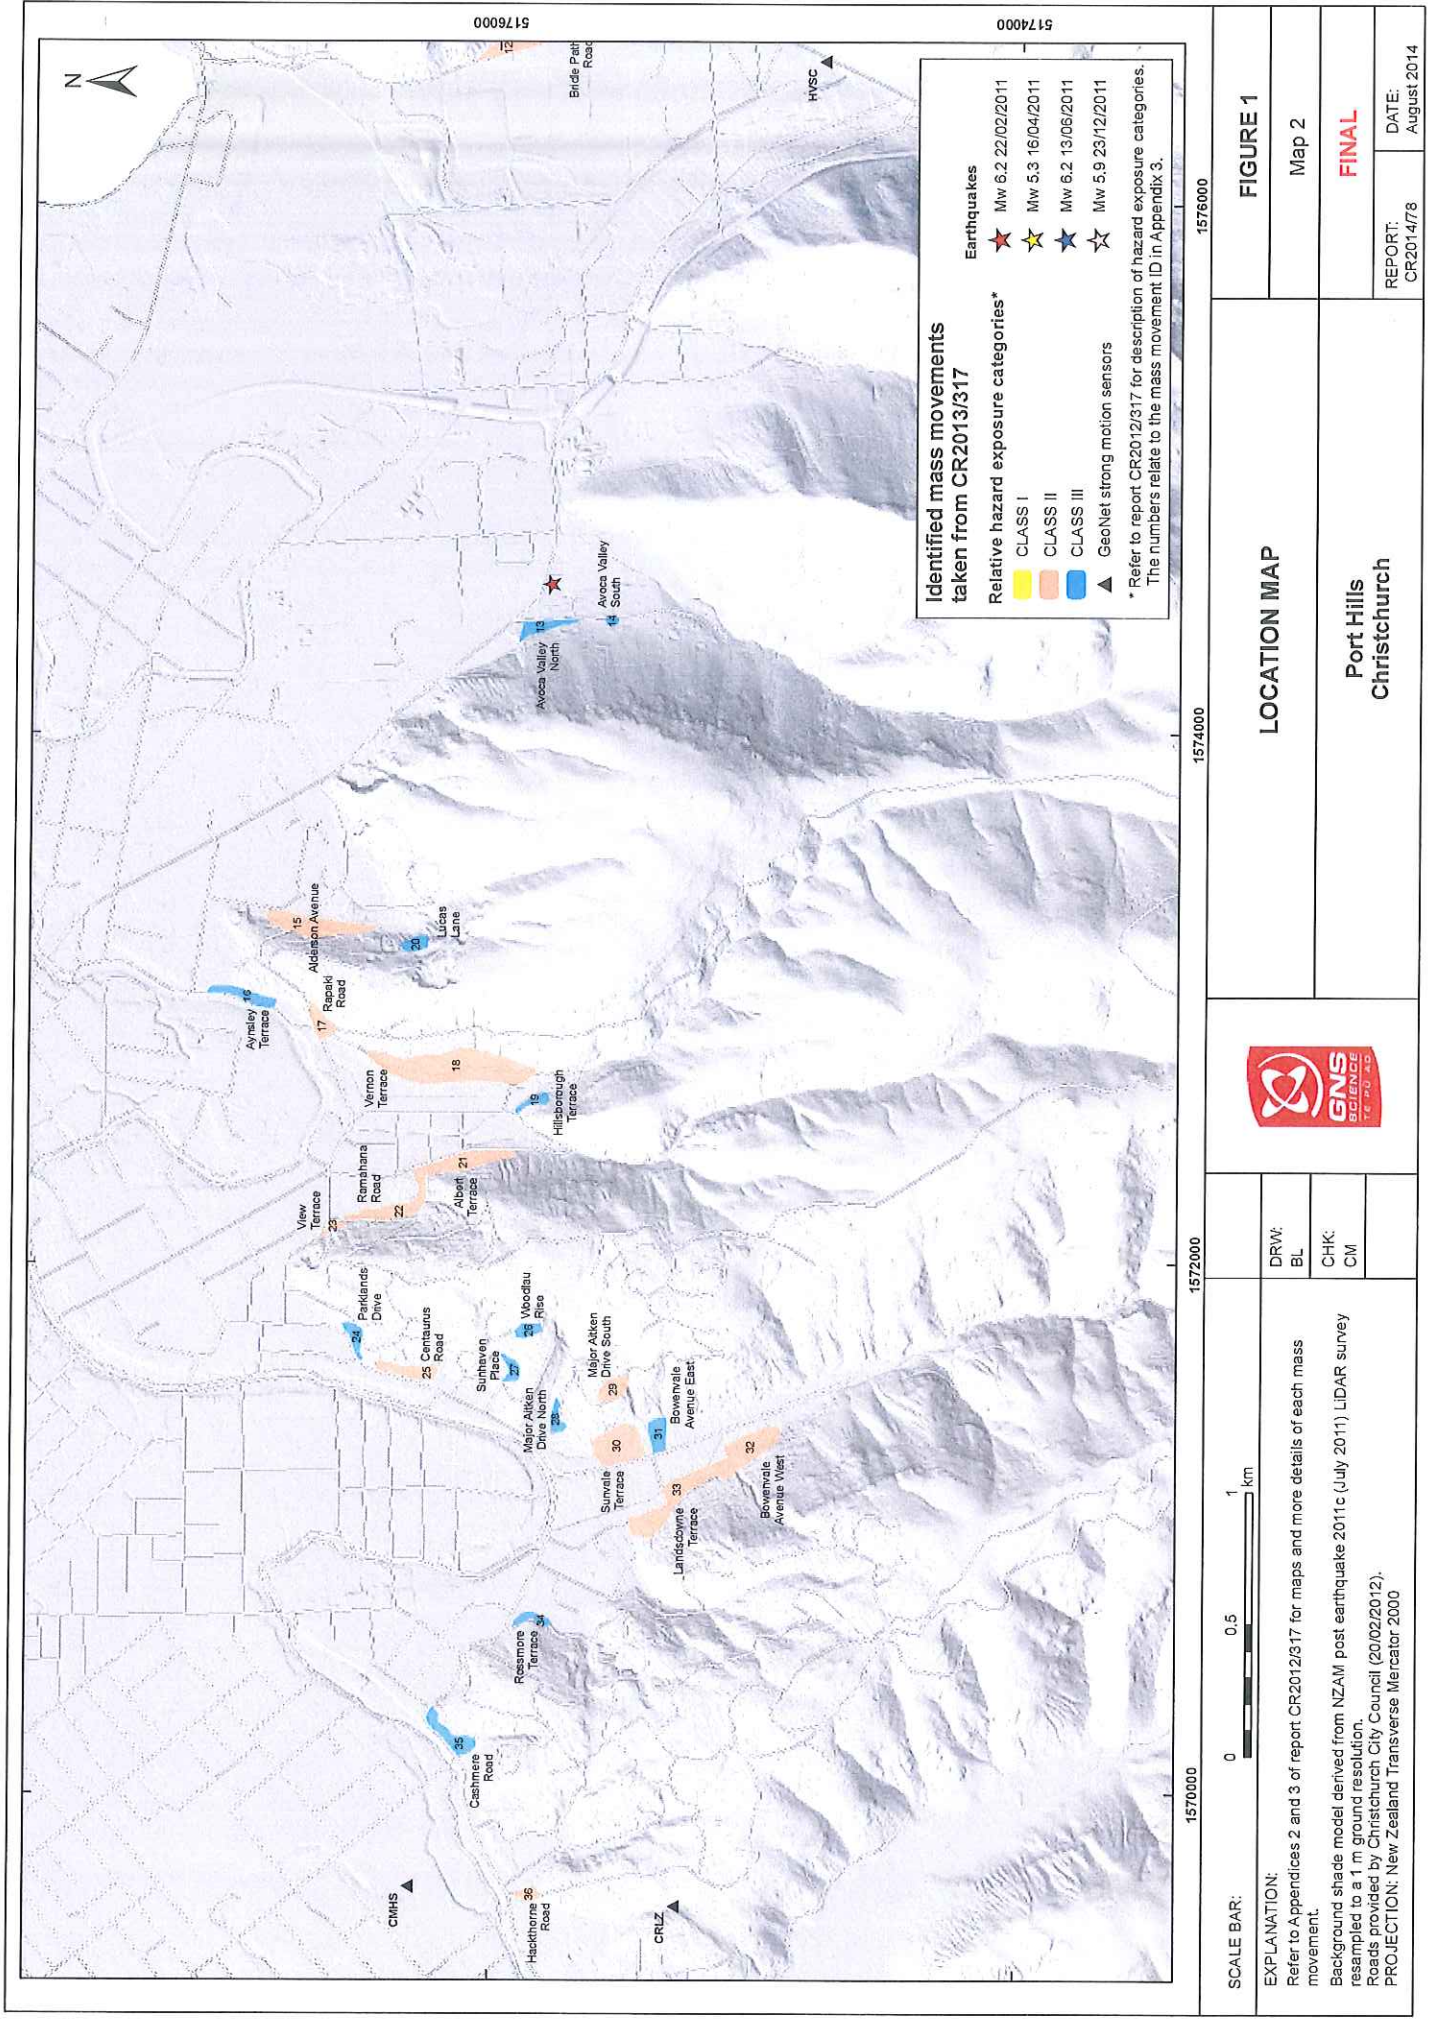
EXPLANATION:
Refer to Appendices 2 and 3 of report CR2012/317 for maps and more details of each mass movement.
Background shade model derived from NZAM, post earthquake 2011c (July 2011) LIDAR survey resampled to a 1 m ground resolution.
Roads provided by Christchurch City Council (20/02/2012).
PROJECTION: New Zealand Transverse Mercator 2000

The Stage 1 report identified 36 mass movements of concern in the Port Hills project area. Four of these were further subdivided based on failure type, giving a total of 46 mass movements including their sub areas (Figure 1). Fifteen of these were assessed as being in the Class I (highest) relative hazard-exposure category. The results of their detailed investigation and assessment are presented in Stages 2 and 3, which includes this (Stage 2) report on the Redcliffs mass movement. The Redcliffs study area includes the Glendever Terrace (8) and Balmoral Lane (9) mass movements shown on Figure 1. Mass movements assessed as being in the Class I category may cause fatalities severe damage to dwellings and/or damage critical infrastructure leading to loss of services for many people if the hazard were to occur.

The Redcliffs mass movement area is shown in Figures 1 and 2. This mass movement area was assessed in the Stage 1 report (Massey et al., 2013) as being in the highest relative hazard exposure category (Class I). During the 22 February 2011 earthquake, two people were killed from falling rock at Redcliffs; one person was inside a dwelling and another was in their garden, both at the bottom of the slope in the debris runout zone. The risk to life of people in dwellings at the slope crest and toe from debris avalanche and cliff top recession hazards (collectively termed cliff collapse) presented in this report provides an update from the original risk assessment for Redcliffs presented by Massey et al. (2012a).

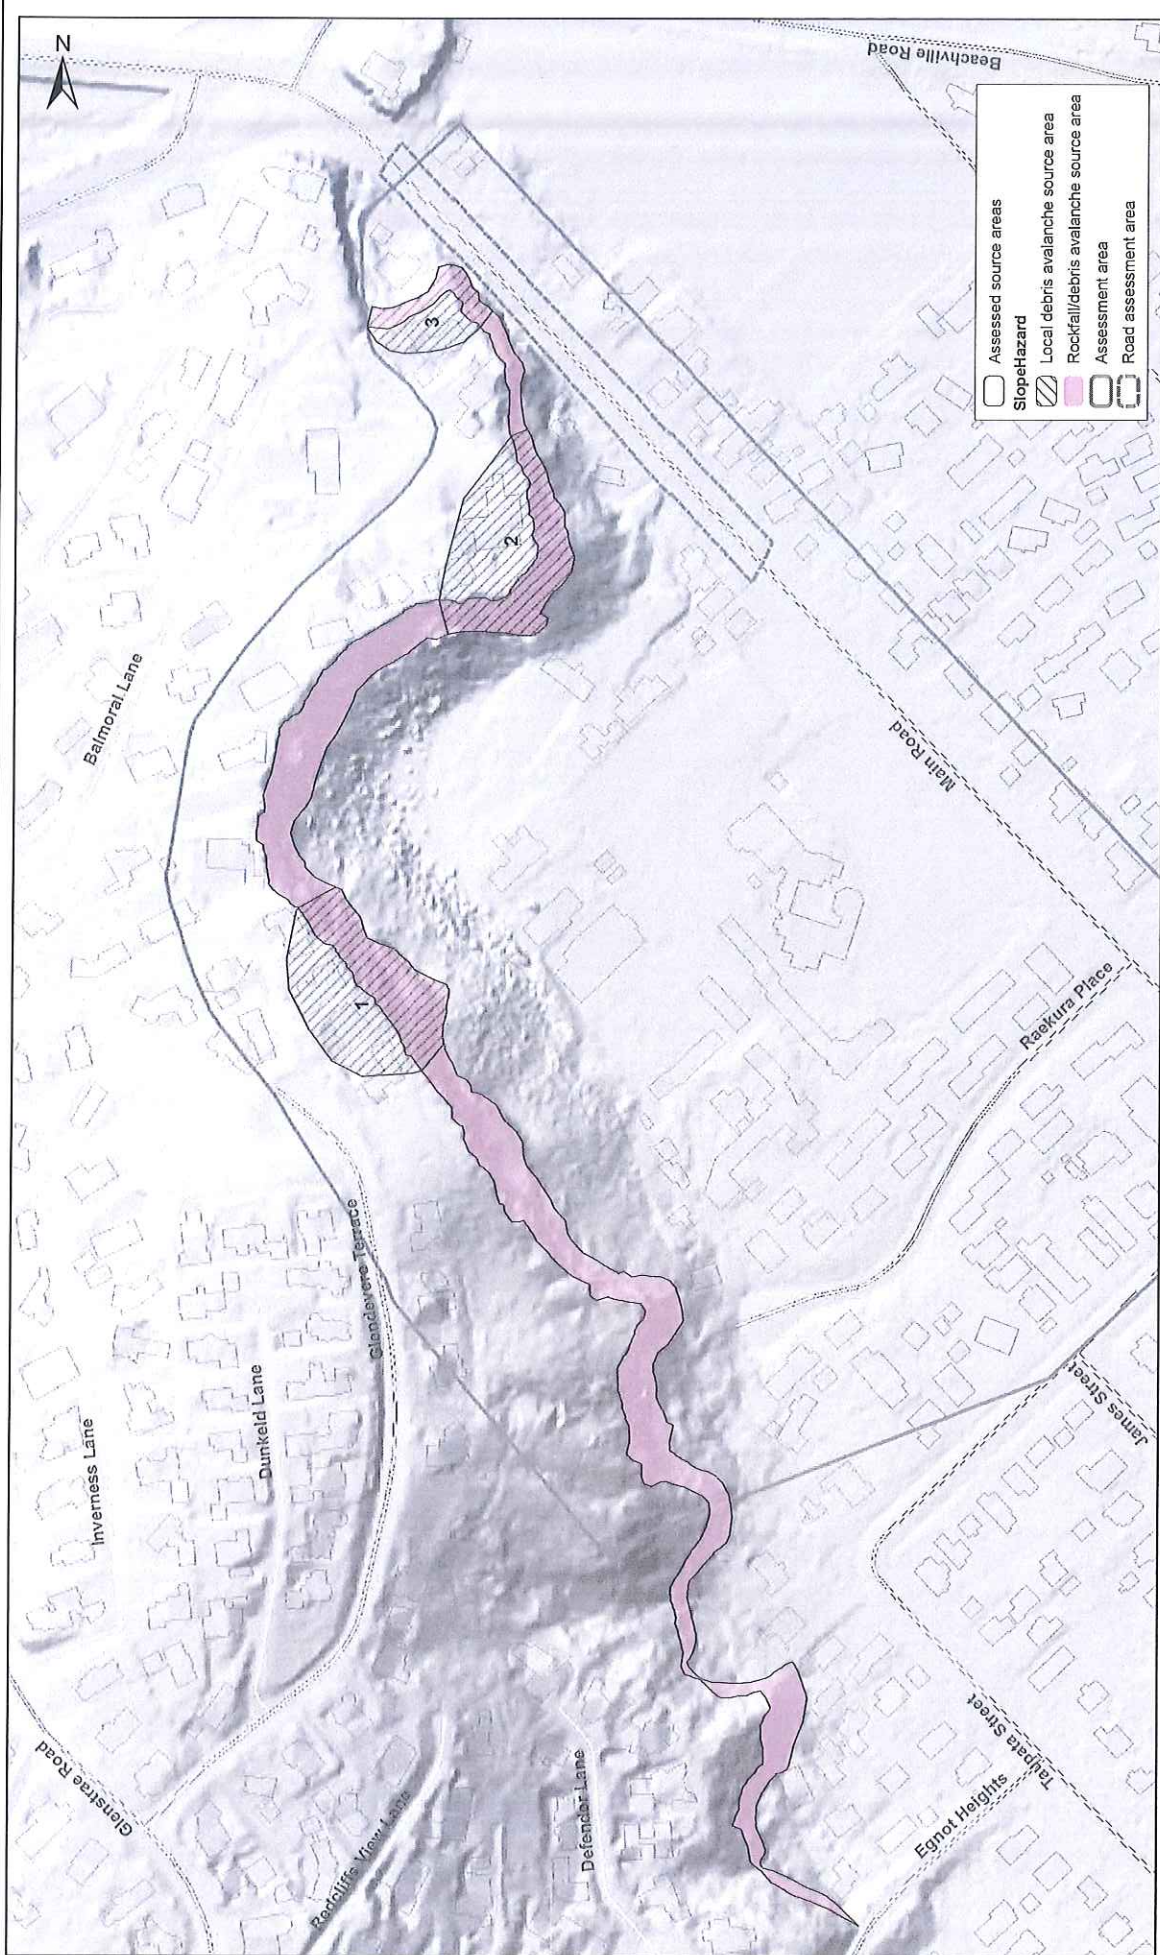
SCALE BAR: 0 50 100 m		DRW: BL		FIGURE 2	
EXPLANATION: Background shade model derived from NZAM post earthquake 2011c (July 2011) LIDAR survey resampled to a 1 m ground resolution. Roads and building footprints provided by Christchurch City Council (20/02/2012). PROJECTION: New Zealand Transverse Mercator 2000		CHK: CM, FDP		MASS MOVEMENT LOCATION MAP	
				Redcliffs Christchurch	
				FINAL	
				REPORT: CR2014/78	DATE: August 2014

This is the reason for the Redcliffs mass movement being included in the Class I (high priority for further investigation) mass movements. The Redcliffs assessment area is shown on Figure 2 and this report presents: 1) annual individual fatality risks for given users of Main Road; and 2) revised annual individual fatality risks for dwelling occupants, within the given assessment area, which take into account the assessed source areas 1–3. Recommendations are provided to assist Christchurch City Council in considering potential options to mitigate the risk.
